Revision Guide for AMD Family 15h Models 10h-1Fh Processors

Publication # 48931	Revision: 3.06
Issue Date: July 2012

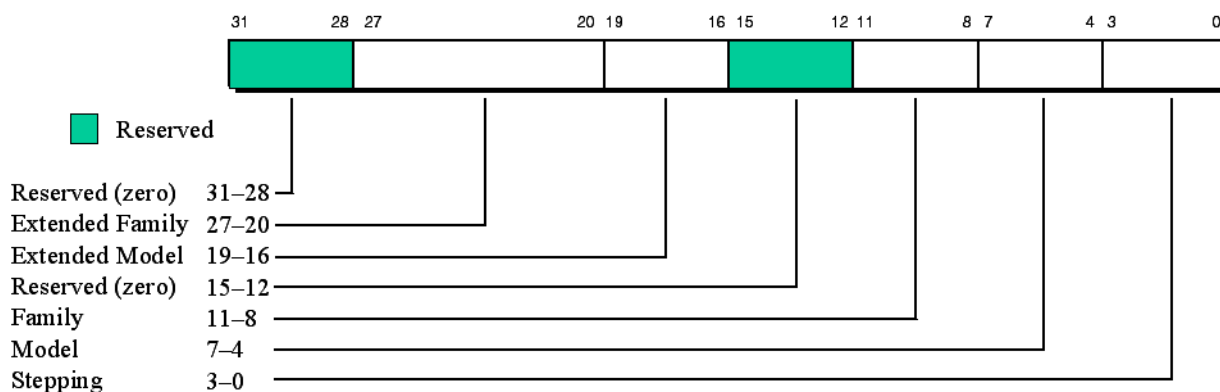
Figure 1. Format of CUID Fn0000_0001_EAX

A processor revision is identified using a unique value that is returned in the EAX register after executing the CUID instruction function 0000_0001h (CUID Fn0000_0001_EAX). [Figure 1](#) shows the format of the value from CUID Fn0000_0001_EAX. In some cases, two or more processor revisions may exist within a stepping of a processor family and are identified by a unique value in D18F4x164 Fixed Errata Register (see [D18F4x164 Fixed Errata Register](#)).
